**TRUCKEE-TAHOE AIRPORT**  
TRUCKEE, CALIFORNIA

**PART 77 AIRSPACE**

DESIGN: BM DRAWN: TE/BM DATE: JULY 2015 SHEET 4 OF 11

Truckee Tahoe Airport Land Use Commission  
Truckee Tahoe Airport  
Land Use Compatibility Plan  
(Adopted October 27, 2016)

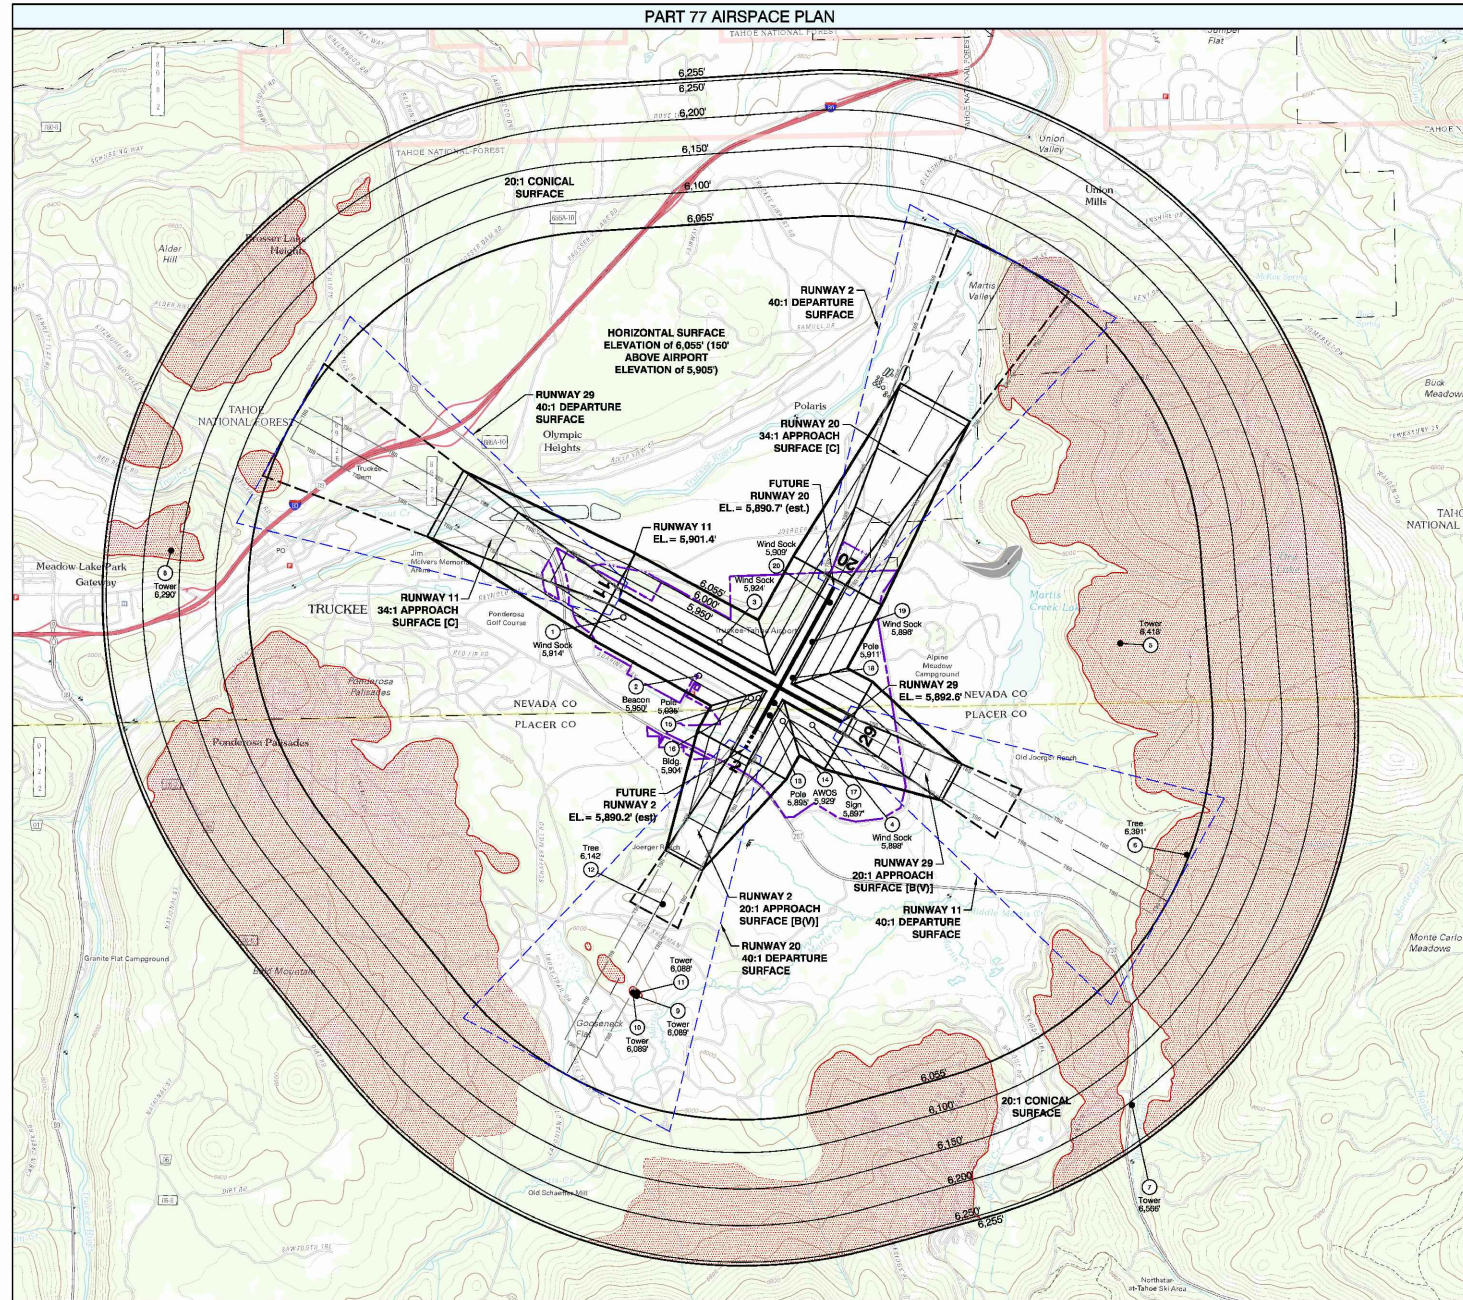
PART 77 OBJECTS									
POINT #	OBJECT DESCRIPTION	OBJECT ELEVATION	AFFECTED PART 77 SURFACE	PART 77 SURFACE ELEVATION	PART 77 SURFACE PENETRATION	THRESHOLD SETTING SURFACE PENETRATION	THRESHOLD SETTING SURFACE ELEVATION	DEPARTURE SURFACE PENETRATION	DISPOSITION
1	Wind Sock	8,814	Transition	8,997	-183	Object not under surface	N/A	Object not under surface	No Action
2	Beacon	8,887	Transition	8,997	-110	Object not under surface	N/A	Object not under surface	No Action
3	Wind Sock	8,884	Transition	8,997	-113	Object not under surface	N/A	Object not under surface	No Action
4	Wind Sock	8,889	Transition	8,997	-108	Object not under surface	N/A	Object not under surface	No Action
5	Tower	8,418	Horizontal	8,997	579	Object not under surface	N/A	Object not under surface	Obstruction Light
6	Tower	8,911	Horizontal	8,997	86	Object not under surface	N/A	Object not under surface	Obstruction Light
7	Tower	8,897	Conical	8,152	745	Object not under surface	N/A	Object not under surface	Obstruction Light

8	Tower	8,997	Conical	8,152	845	Object not under surface	N/A	Object not under surface	Obstruction Light
9	Tower	8,089	Horizontal	8,997	908	Object not under surface	N/A	Object not under surface	Obstruction Light
10	Tower	8,089	Horizontal	8,997	908	Object not under surface	N/A	Object not under surface	Obstruction Light
11	Tower	8,089	Horizontal	8,997	908	Object not under surface	N/A	Object not under surface	Obstruction Light
12	Tower	8,142	Horizontal	8,997	855	Object not under surface	N/A	Object not under surface	Obstruction Light
13	Flt	8,887	Primary	8,997	110	Object not under surface	N/A	Object not under surface	No Action
14	AWOS	8,889	Transition	8,997	-108	Object not under surface	N/A	Object not under surface	No Action
15	Flt	8,887	Transition	8,997	-110	Object not under surface	N/A	Object not under surface	No Action
16	Building	8,887	Transition	8,997	-110	Object not under surface	N/A	Object not under surface	No Action

17	Flt	8,887	Primary	8,997	110	Object not under surface	N/A	Object not under surface	No Action
18	Flt	8,811	Primary	8,997	186	Object not under surface	N/A	Object not under surface	No Action
19	Wind Sock	8,889	Primary	8,997	110	Object not under surface	N/A	Object not under surface	No Action

Note: A negative penetration value indicates the object is clear of the airspace surface. Objects listed by aeronautical function.

- Only airspace surfaces associated with ultimate runway configurations are illustrated. All objects are analyzed against the ultimate airspace surfaces.

- Runway elevation data source: As built engineering documents from airport management and R.W. Brandley Engineering (2014).
  - Objects elevation source: Digital Obstacle File (Nov. 12, 2013 release) and 1993 20:1 Obstacle Survey (2 objects - others recently removed). ADIS survey recommended to help document any potential obstruction to approaches.

- Base map source: USGS Topographic maps.
  - See Inner Approach Sheets 6 and 7 for close-in obstructions in RPZ areas.
  - Proposed Runway 2-20 extension and widening project will require an Aeronautical Survey for support of amended Instrument Approach Procedures.
