# 2015 State of the Pavement Report

California Department of Transportation  
Division of Maintenance  
Pavement Program  
December 2015

This report is prepared by the California Department of Transportation, Division of Maintenance, Pavement Program, Office of Planning and Programming and Office of Pavement Management and Performance. It summarizes the 2015 pavement condition survey on the entire Caltrans network.

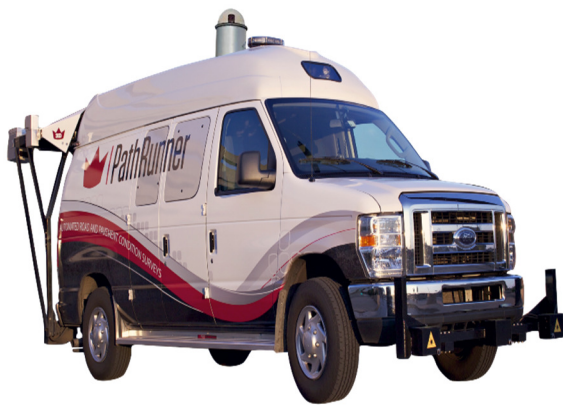
APCS pavement Data Collection

Using new technology, Caltrans has invested in the APCS which uses high definition images and lasers to measure every lane on the system. This data can predict the future network performance and will be used to track sustainability and pavement health. In the past, Caltrans conducted the PCS once a year to measure the changes in the pavement condition on the nearly 50,000 lane mile system. The PCS was a visual inspection conducted along the outside highway lanes in both directions using systematic sampling techniques. Condition assessments were made for the entire highway system based on those sample inspection. The 2015 PCS was started in June 2013 and completed in January 2015.

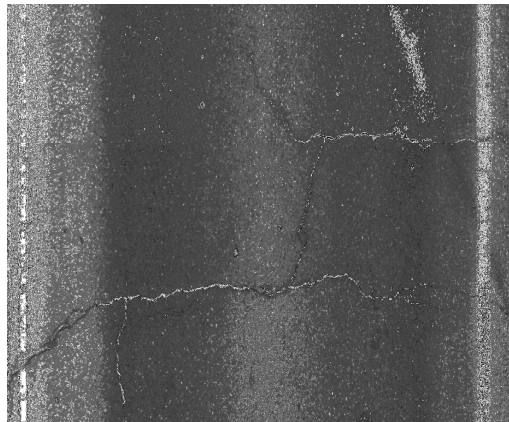
Example of High Definition Cracking Image
